Richmond Refinery LPS Bulletin – Reliability

Leaking Ports at TKN Reactor Module R-520

Location: North Isomax TKN
Reactor Module R-520

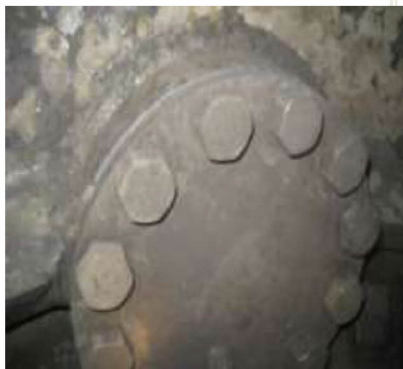
Bolts at typical bottle reactor liner ports

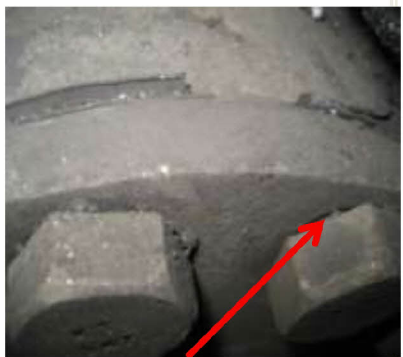
Visible gaps at bottomed out bolts

- 1) 1/8" gaps were left between the two bottom liner port flange covers and gasket surfaces.
- 2) Liner ports were not checked or leak tested prior to loading catalyst.
- 3) An investigation of R-510 liner damage in 2002 did not address prior problems at liner ports as a potential root cause for feed bypassing.

- 1) Drawings and instructions for assembly and testing should be provided for special flanges such as bottle reactor liner ports.
- 2) Checklists must include pertinent details of each reactor as was done for the nine subsequent successful catalyst changes at Isomax and RLOP.
- 3) Loss Investigations should address all potential causal factors rather than only the proximate root cause for the incident. (see below)
